TEST DATA REPORT

BeeAlert Spray Test

By: Paul W. Jackson
Texas State Entomologist
Head of Apiary Services
Texas A&M University

Test I & II Data Report - BeeAlert Tractor Spray Test

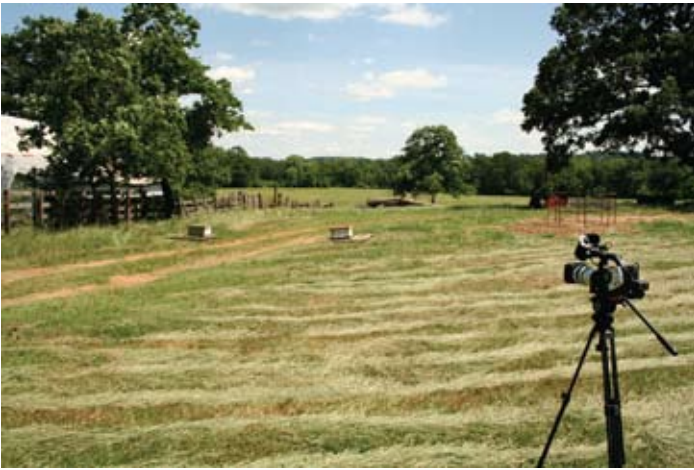
Figure 1. Simulated bee attack area with hive entrance facing toward the field road.

The Phase I test was conducted by having the tractor operator drive toward a simulated bee attack area (fig. 1) and activate the BeeAlert spray system approximately 50 feet before entering the test zone. To simulate a bee attack the operator wore no bee protection, he is dressed in jeans, t-shirt and ball cap. Prior to entry into the test zone, the bee hives were agitated by the test coordinator in a bee protection suit. Once inside the test zone, the driver will keep the BeeAlert system on and stop the tractor for two minutes (fig. 2). The driver was satisfactorily protected during this period and received only one bee sting. After the two minute whistle warning, the driver proceeded forward (fig. 3) for a distance of approximately 620 feet before the spray system was cut off. The spray system ran for a period of 4 minutes and 31 seconds before draining the 9 gallon tank (fig. 4). The above test was video taped.

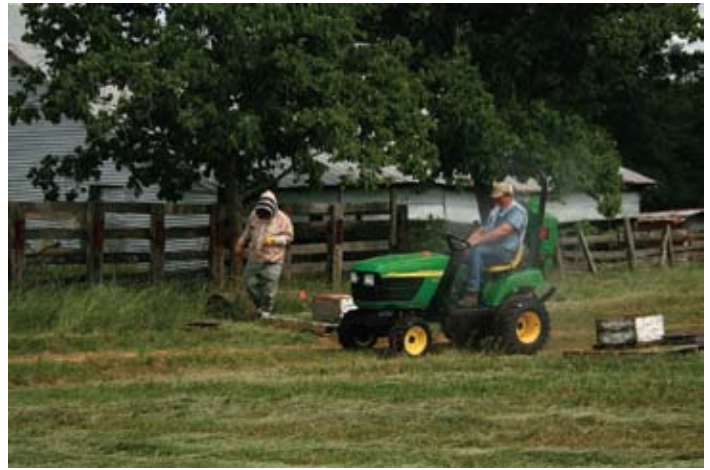
Figure 2. Tractor parked between hives in test area for two minutes, spraying driver and giving protection against honey bee attack.

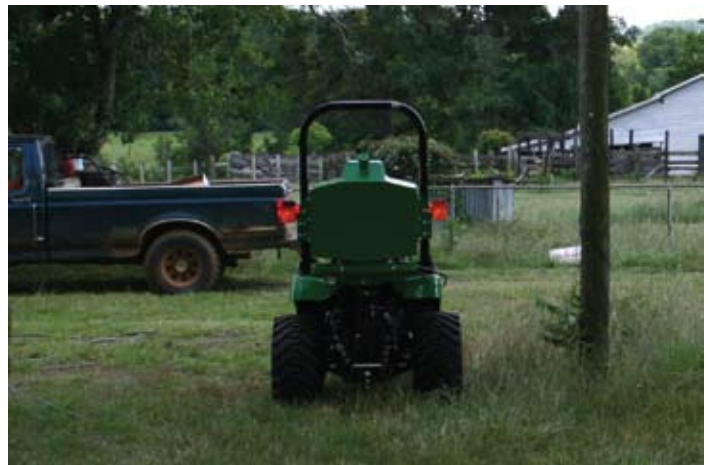
Figure 4. BeeAlert tank on back of tractor.

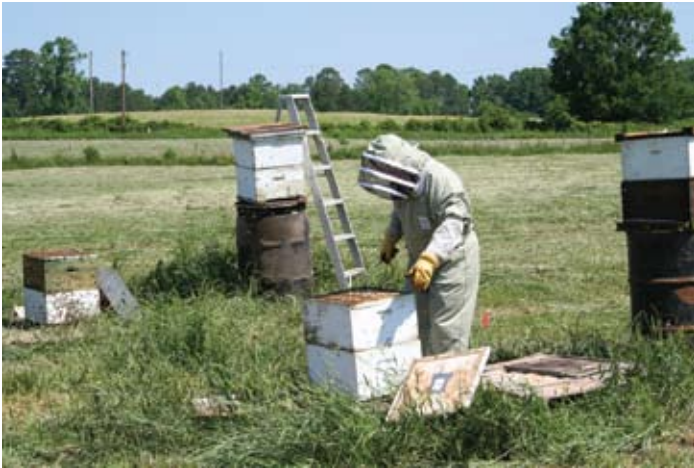
Figure 5. Showing 4 double deep boxes with 2 hives on drums.

Test II was conducted with four honey bee hives averaging 35,000 - 45,000 bees per colony. Two hives were placed on drums with entrances facing toward the driver's upper body, giving maximum exposure to the face and chest area (fig. 5). All hives were agitated by shaking and pulling frames from each colony, simulating a bee attack. The unprotected driver activated the BeeAlert spray system approximately 50 feet before entering the test area (fig. 6). Once inside the test area, the driver will keep the BeeAlert system on (fig. 7) and stop for a period of one minute. The driver was satisfactorily protected during this period while receiving only two bee stings. Then the driver drove out of the test area (fig. 8) for a distance (fig. 9) of 978 feet before the BeeAlert system depleted the 9 gallon tank.

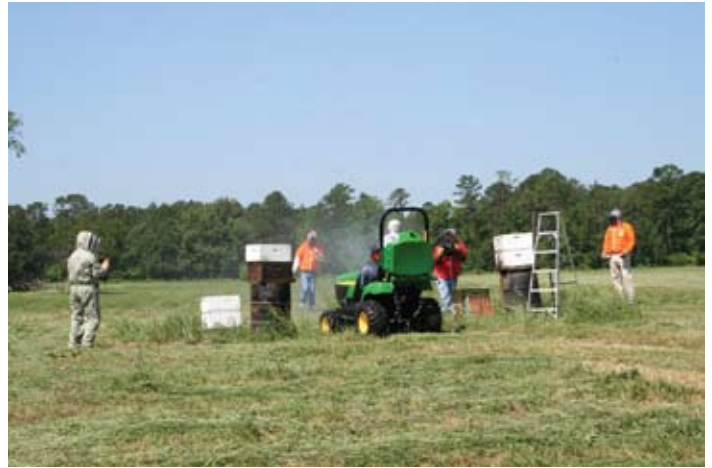
Figure 6. Entering test area with BeeAlert system on.

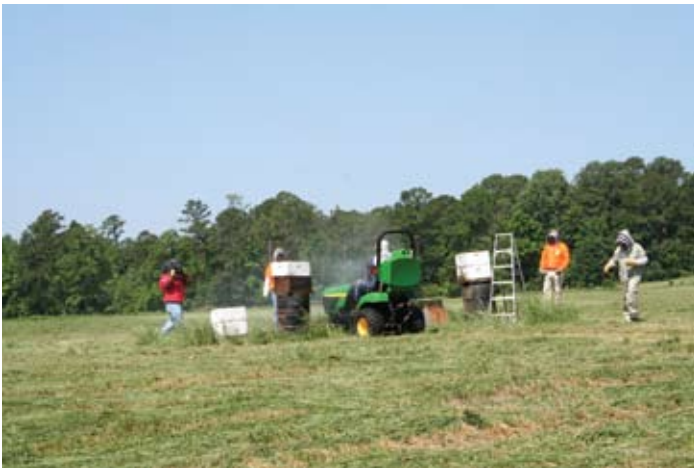
Figure 7. Driver parked in center of test area for one minute.

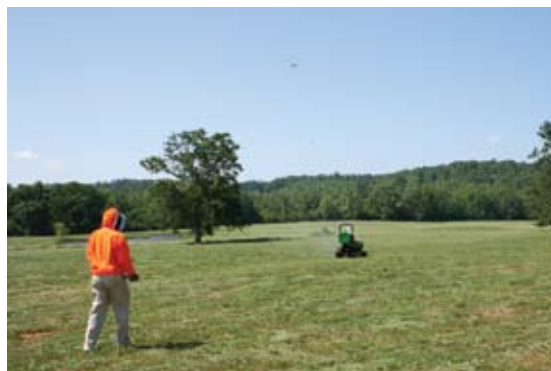
Figure 9. Tractor travelled 978 feet. Driver was unharmed by the non-toxic BeeAlert chemicals

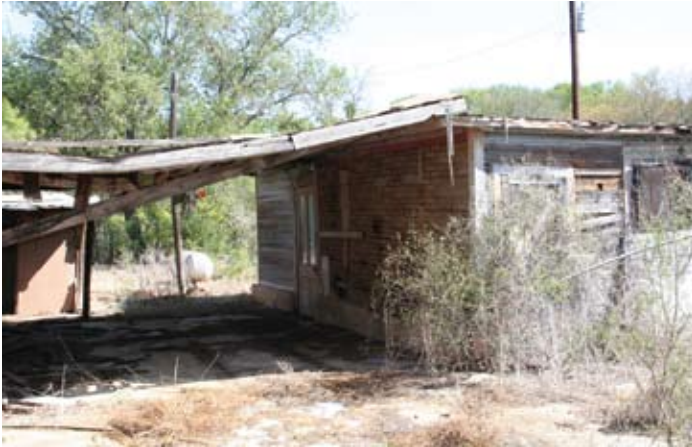
Fig 1. Hive entrance facing carport.

The Phase III test was conducted with an Africanized Honey Bee feral colony inside a ranch house. Hive entrance was a facing carport (fig. 1), and the feral nest was estimated to contain 20,000-30,000 bees. The nest was agitated by shaking and pulling pieces of siding from entrance causing bees to attack. The driver activated the BeeAlert spray system approximately 50 feet before entering the carport (fig.2). Once inside the test area (fig. 3), the unprotected driver kept the BeeAlert system on and stopped the tractor for one minute. The driver was satisfactorily protected during this period and received only four bee stings. After the one minute whistle warning, the driver proceeded forward (fig. 4) for a distance of approximately 425 feet before the spray system was cut off. The BeeAlert spray system used approximately 9 gallons of solution and allowed the driver to operate his tractor around trees and drive to a bee free area (fig. 5). The above test was video taped (fig. 6).

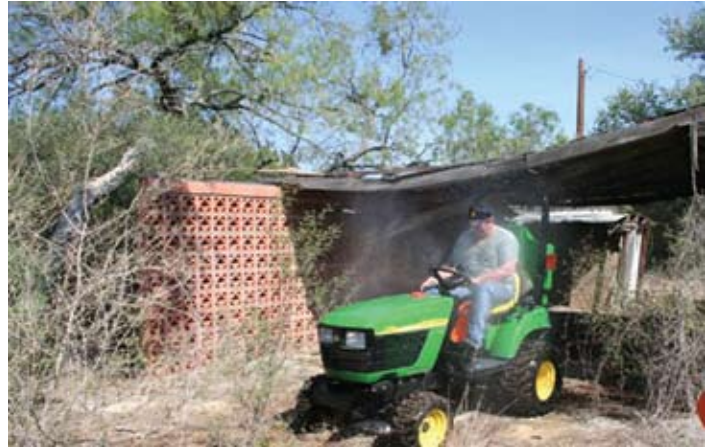
Fig 2. Tractor entering carport, spraying driver and protecting against Africanized Honey Bee attack.

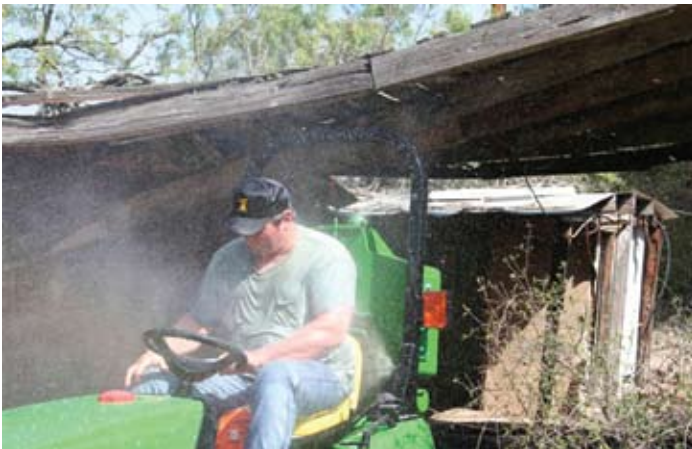
Figure 3. BeeAlert system on for one minute

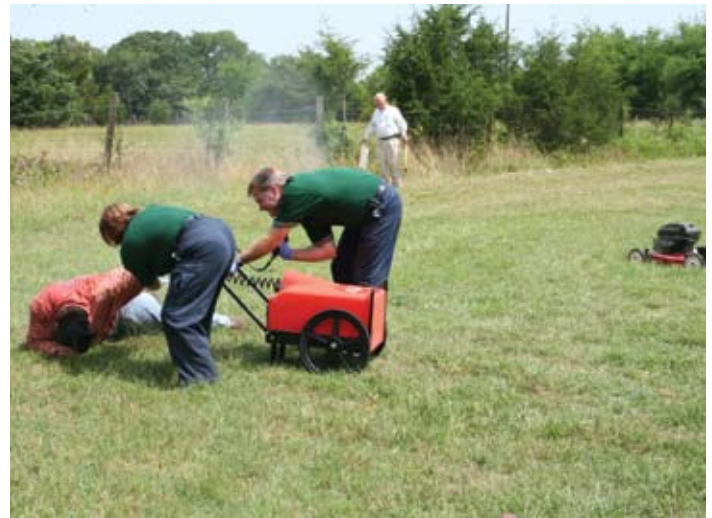
Figure 6. EMTs use the BeeAlert Portable Sprayer to rescue homeowner

The Phase IV test was conducted with European Honey Bees on a 2 acre home site (fig. 1) near Bryan, Texas. The hive entrance was facing the driveway (fig. 2) and colony strength was estimated to contain 20,000 – 30,000 bees. The owner of the property was mowing the yard (fig. 3) and was attacked by bees when he came too close to the hive (fig. 4). The wife notified emergency personnel and EMT's (fig. 5) arrived quickly to the area. The BeeAlert Portable Sprayer (fig. 6) which contained approximately 9 gallons of solution was used to retrieve the person from the hazardous area and moved to a non-hazardous area in the vehicle. The above test was video taped.
